Upgrading Luminex IS 2.3 to Bio-Plex Manager™ 6.1 Software

For technical support, call your local Bio-Rad office, or in the US, call 1-800-424-6723.

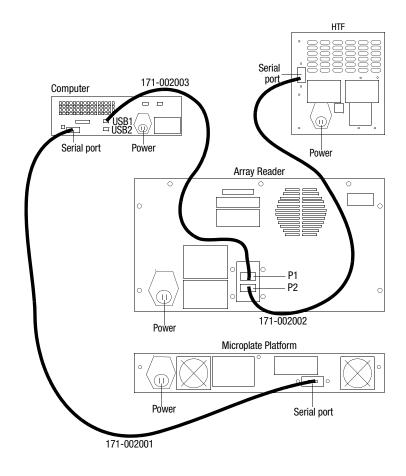
Prior to using the newly-installed Bio-Plex Manager [™] 6.1 software, verify that the firmware level of each of the components is current, as described in the following steps.

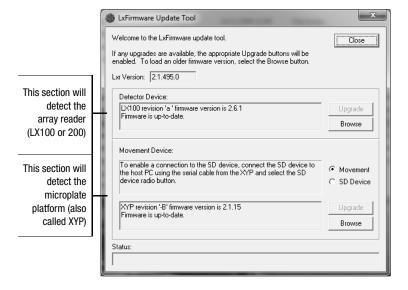
The Detector Device box detects the array reader, and the Movement Device box detects the microplate platform. The Movement Device of the HTF is detected later in the process.

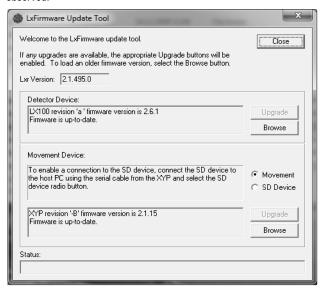
NOTE: If the LxFirmware Update Tool does not detect both devices after 3 minutes, turn the devices off and on. If the devices are still not detected, confirm that the cables are firmly connected as shown on page 8, reboot the computer, and repeat step 2. If the devices are still not detected, contact Bio-Rad Technical Support.

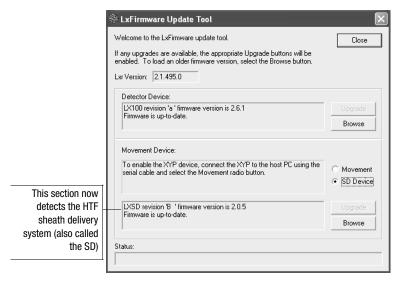
- Record the firmware version for the SD Device ______, in the event there is a problem with the upgrade. The correct firmware version for the LXSD Movement Device is 2.0.5.
- 5. If the message in the Movement Device box states that the SD Device firmware version is already 2.0.5, skip to step 6.

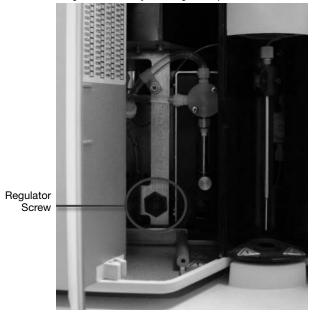
This screw needs to be turned fully clockwise, but you must first determine if it is turned fully clockwise already.
